GHWTP Filter Rehabilitation and Upgrades

PROJECT PURPOSE – WHY?

1. Filters and Plant commissioned in 1960, expanded in 1968 and Modernized in 1986
2. Improve performance
3. Address backwash issues
4. Piping improvements (address air-binding and corrosion issues)
5. Add seismic reinforcing and new coatings

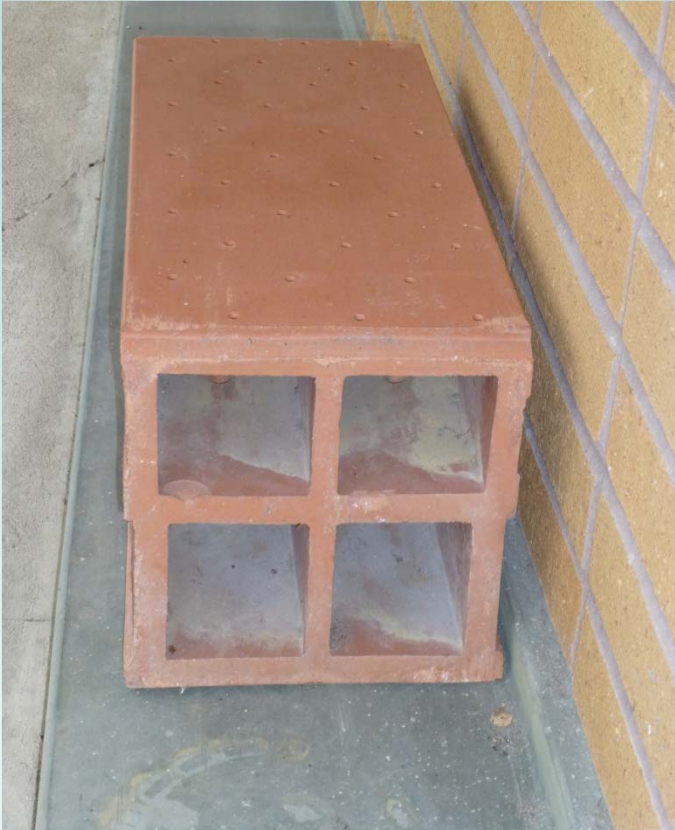
Existing

Clay Tile Underdrain

1. Replace existing clay tile underdrains with low-profile stainless steel underdrains
2. Increase filter media depth
3. Replace filter wash system

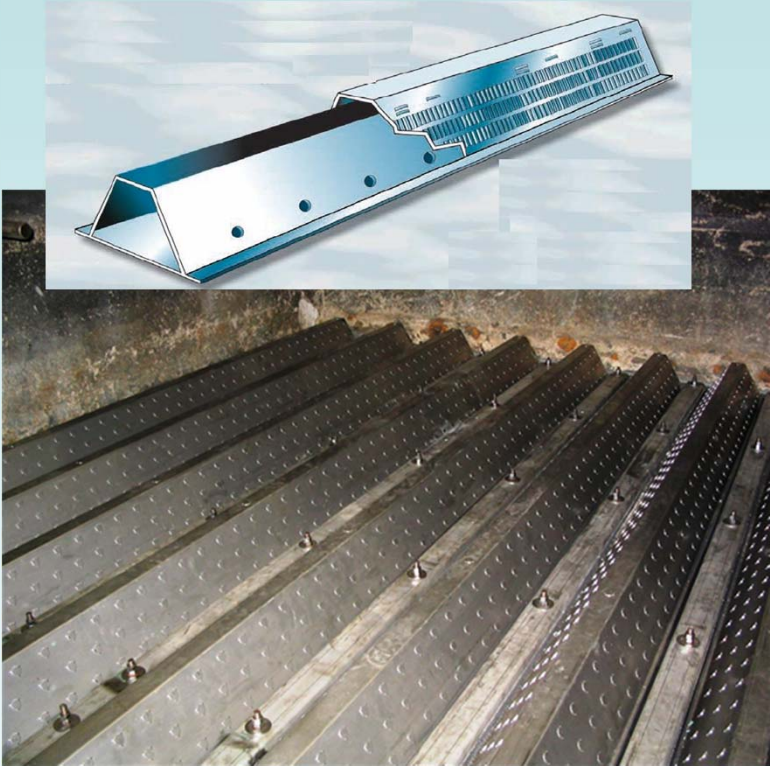
NEW

Stainless Steel Folded Plate Underdrain

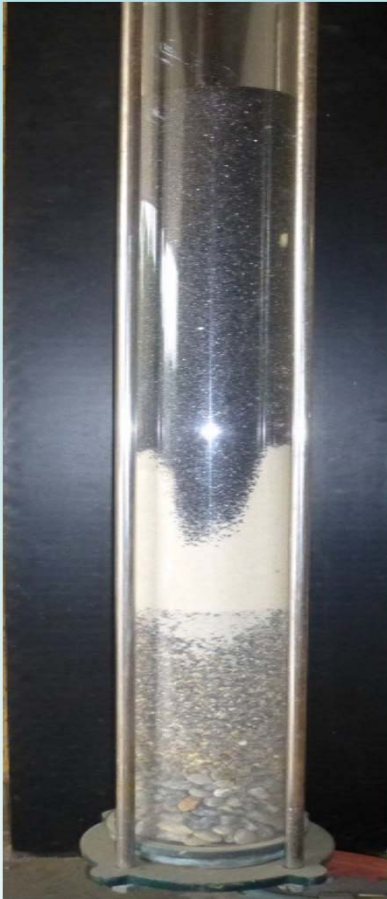
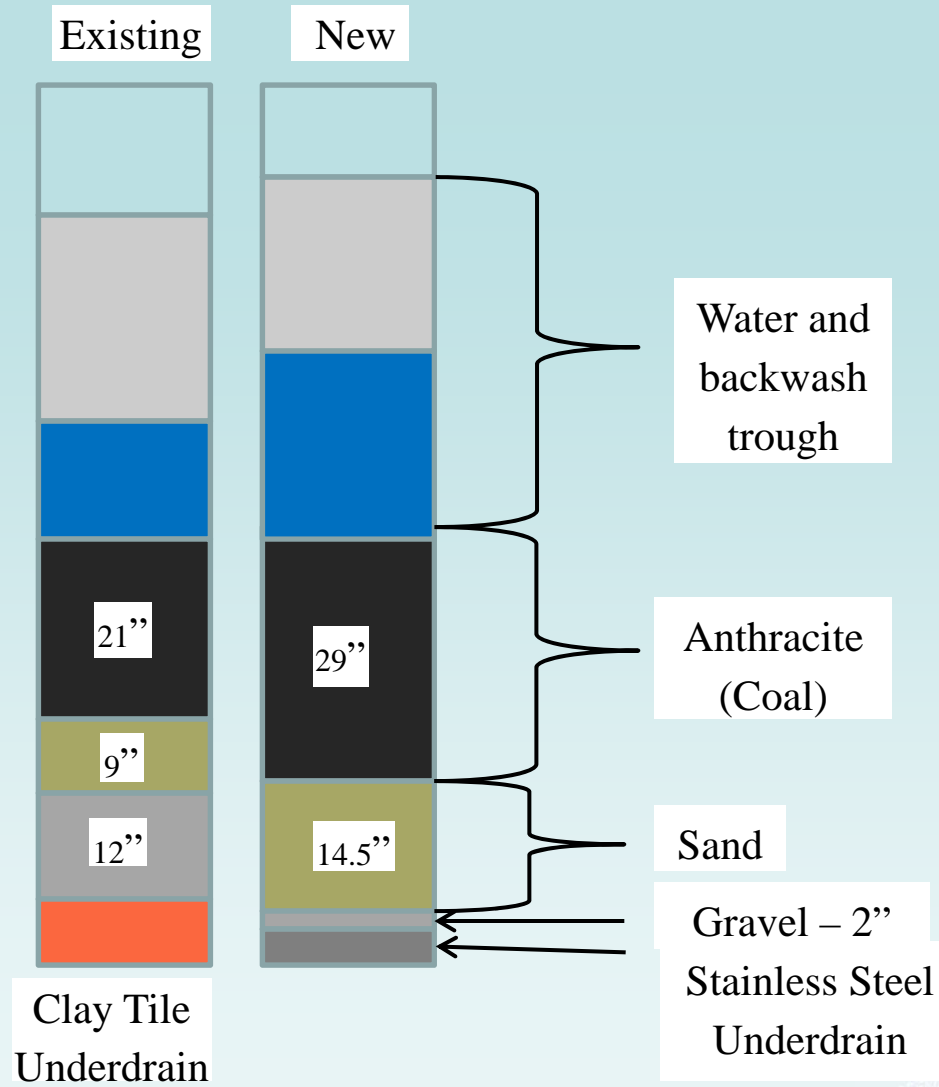
Improve Performance (Media Replacement)

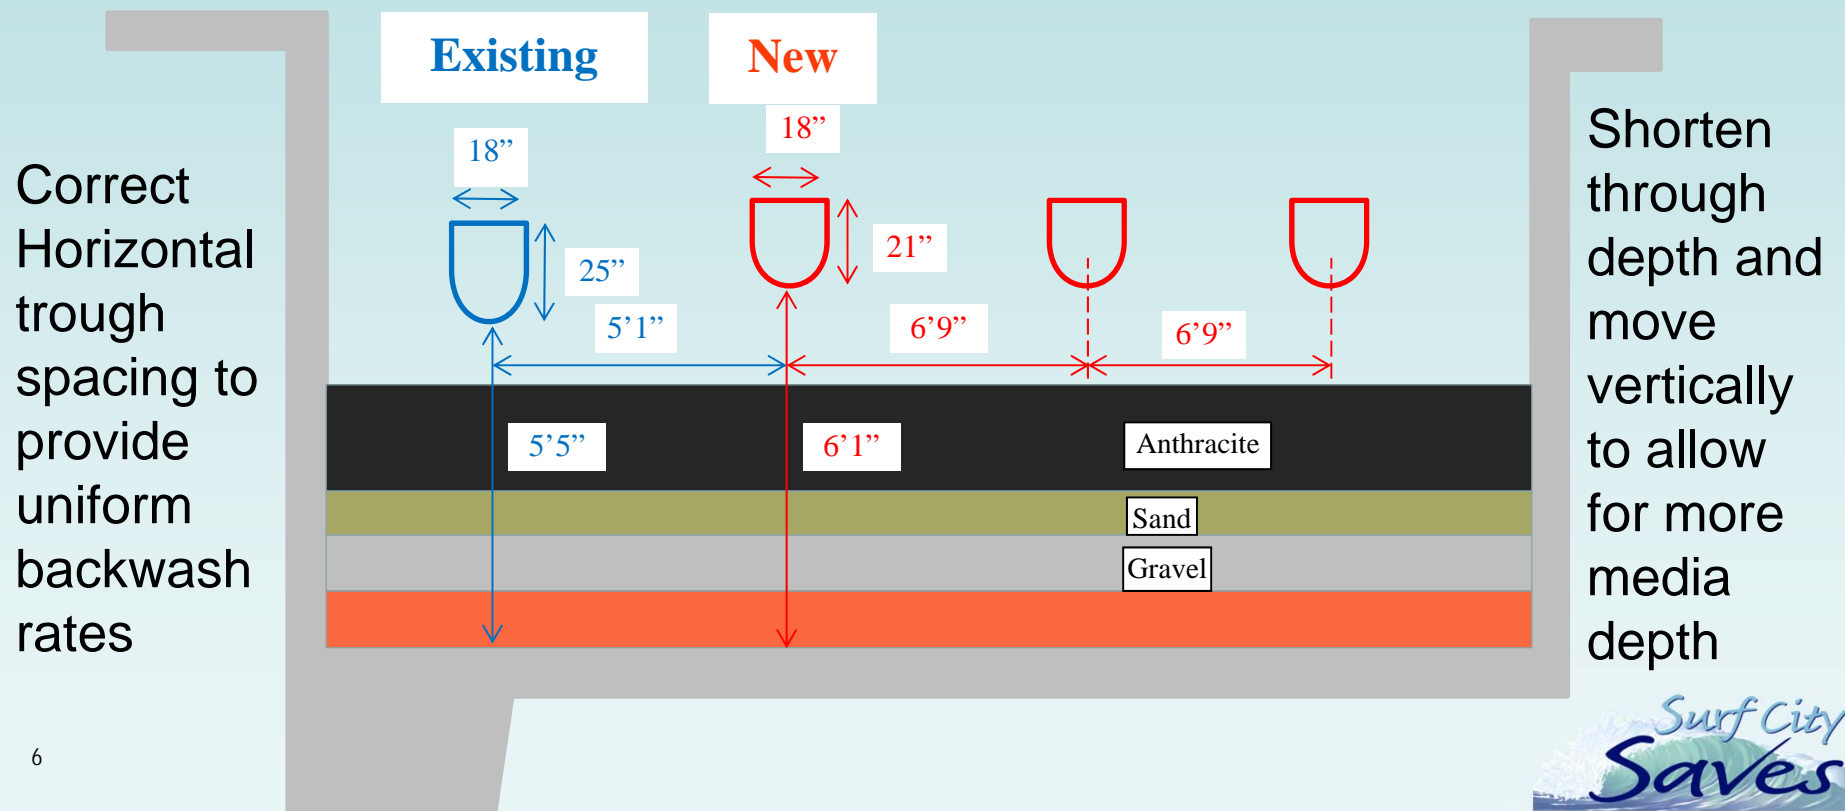
1. Make Washwater Trough Improvements
2. Add Polymer System to Backwash Water

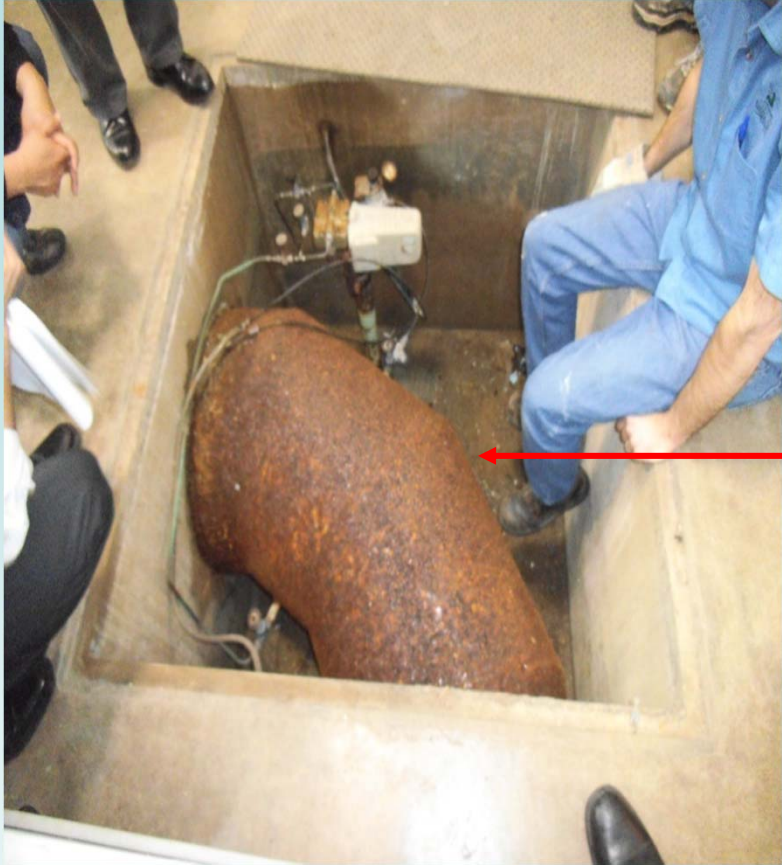
Polymer system addition

Since the plant has no filter to waste capability, polymer will be added to backwash water to mitigate high turbidity in the filtered water after backwashing

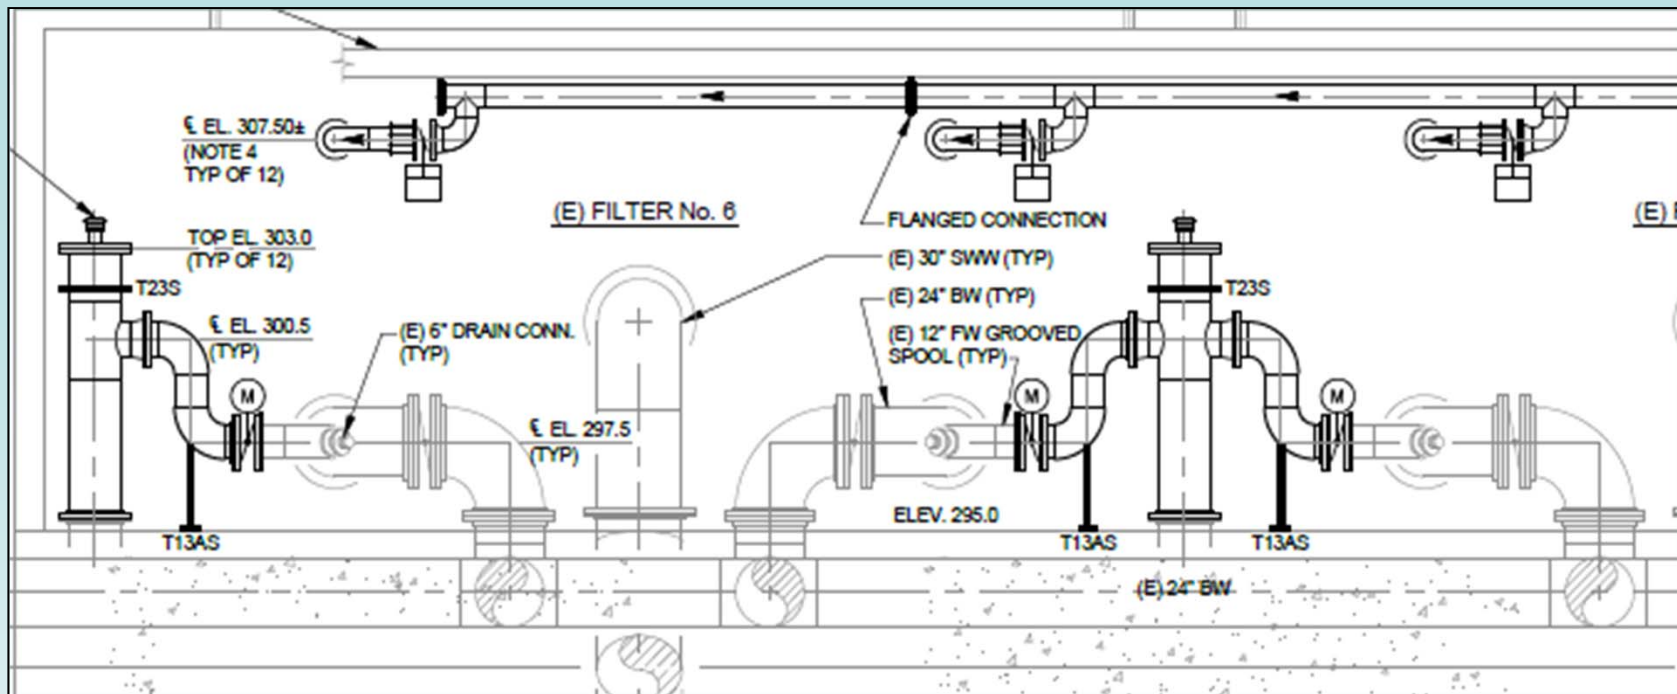
Piping Improvements

Address Air-binding issues by installing standpipes and create a vented discharge that raises the Hydraulic Grade Line to eliminate vacuum condition in filtered water pipe
